An application of microscopic investigation on extracted premolar with dyschromia, related to the components of endodontic sealer

Abstract

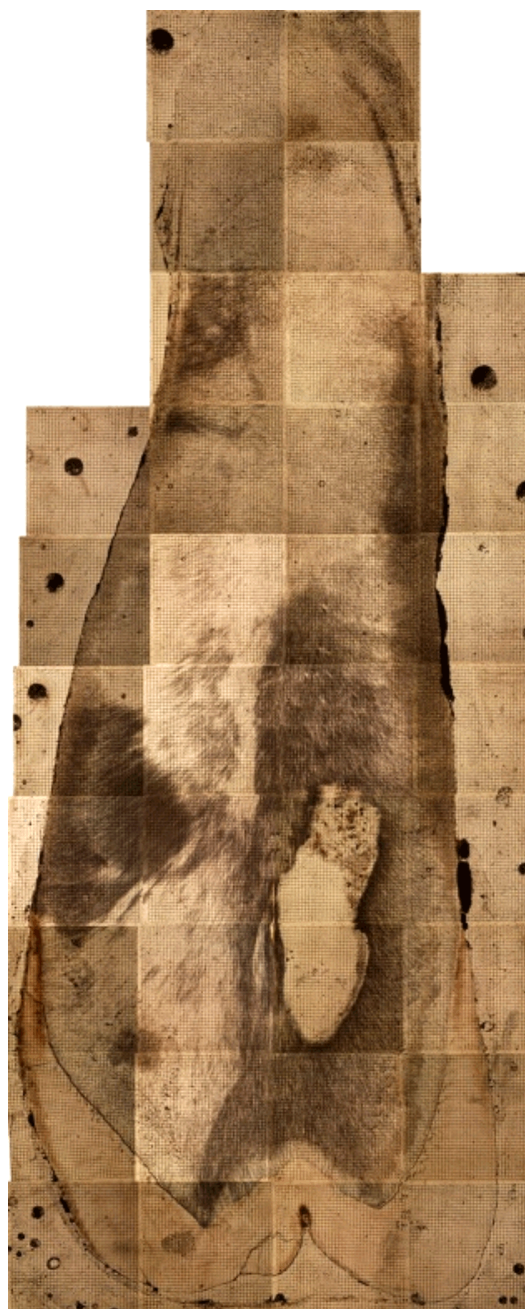
Figure 1 – Composed image (from 1 to 35 photos) that reconstructs the maximum sectional area of the examined tooth surface, by joining all the areas of photographs over which was superimposed the determination grid.

To give the appearance of the entire surface of the tooth section, the areas of photos on which the grid was overlapped, have been selected and arranged in proper order in the composed image. The reconstruction of the global image of one of the longitudinal sections achieved on the studied tooth was conducted by merging a set of microscopic images, achieved so that the grid used to determine the proportions covered all of its areas (Figure 1).

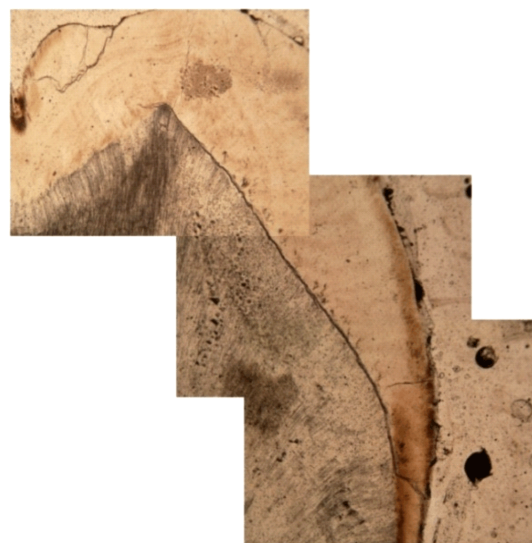
Figure 2 – Image composed of three photos taken serially in transmitted light at 100× magnification, which reveals the position of the cracks localized at the enamel–dentin limit, mainly under the vestibular cusp and on the vestibular slope of it.

During the microscopic study, while tracking the impregnation changes in dentin, we noticed an additional microscopic aspect of non-physiological nature. At the approximate location of enamel–dentin junction, on all the three sections studied, a coronal fracture was detected. It starts from the enamel, under vestibular cusp tip, at the enamel–dentin adjacent limit, relatively following to the limit, going under the vestibular cusp slope and near the enamel–cement junction, at 1.3 mm from coronal, leaving this limit and crosses the thickness of the enamel towards the exterior (Figure 2). In this place, where the crack comes out, the thickness of the enamel determined in micrometers, on the central section (section of maximum area), is 0.35 mm (Figure 3). This crack communicates with the endodontic space in that it is not perfect located on the enamel–dentin limit, under the vestibular cusp and intersects the terminal portion of the dentin tubules (Figure 4). We categorize this rift as open, in that it communicates with both, endodontic and exterior space.

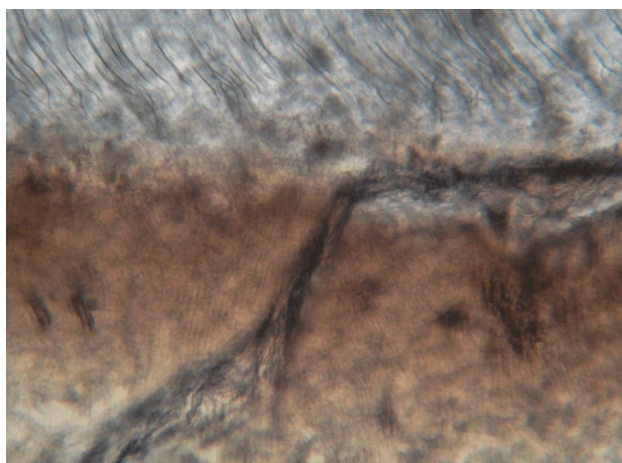
Figure 3 – Detail on the exterior area of the crack output that runs through the enamel exterior, immediately on the coronal cementum–enamel junction. Natural light, 250×.

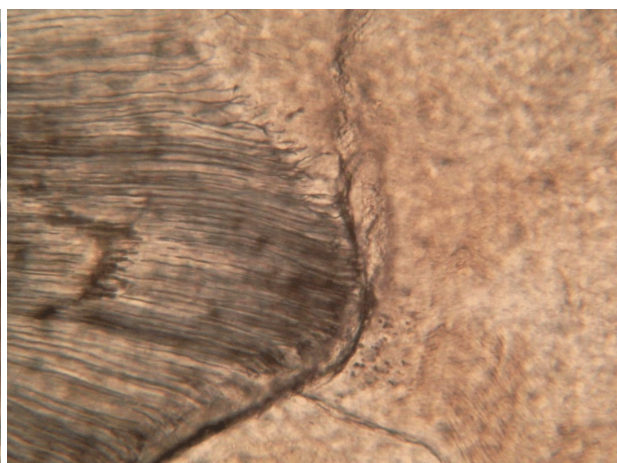
Figure 4 – Detail on the crack that intersects the terminal portion of the dentin tubules under the top portion of the vestibular cusp. Natural light, 250×.

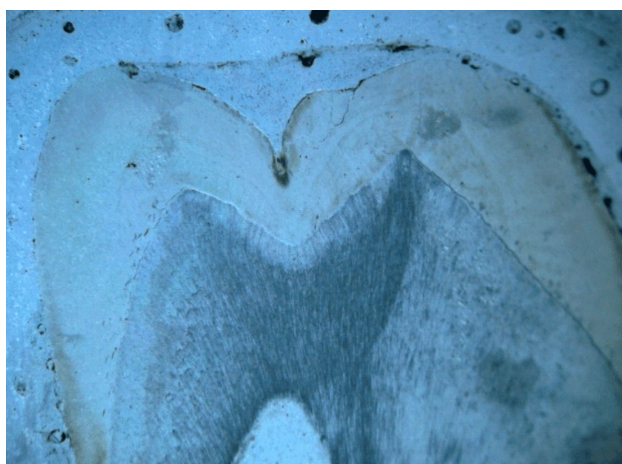
Figure 5 – The premolar crown area investigated by transmitted light stereomicroscopy image (20×).

By using the stereomicroscope with small magnifying orders (e.g., 20×), it is possible encompassing a larger field of the entire crown (Figure 5). In the center of the image, there is an area of deeply impregnated dentin, which is observed as a relative funnel shape. It is noted that the substance did not emerge to the enamel–dentin limit (with few exceptions, such as the area under the vestibular cusps). Thus, it is observed the persistence of a dentin domain, overall non-impregnated, immediately below the enamel–dentin limit. Such an overview allows a rough assessment of the proportion of impregnated dentin, located beneath the enamel.

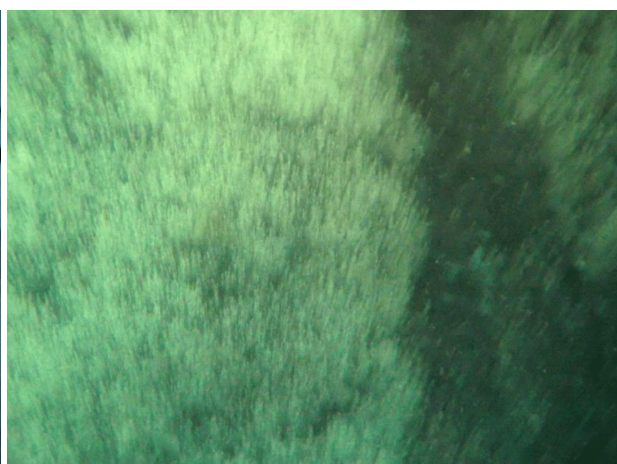
Figure 6 – An image in which the birefringence phenomenon of the impregnated dentin tubules is shown, with sealant components (image left) compared to the areas with few tubules impregnated (right side of image). Polarized light, 250×.

The fact that there is an impregnation with sealant components of the dentin tubules can be highlighted if this substance is anisotropic. Anisotropic foreign content of dentin tubules, in the case of the premolar, is evidenced in Figure 6 by the birefringence phenomenon, when the birefringence colors of the intertubular dentin were canceled by the phenomenon of extinction. The tubules containing no sealant, and categorized as impregnated, do not show this birefringence phenomenon and is observed at the right part of the image. By using microscopic techniques for obtaining such images, basically one depicts the three dimensions routes of the impregnated tubules.
